SUMMARY 1234 Main Street Akron OH 44319 Buyer Name 10/11/2022 9:00AM

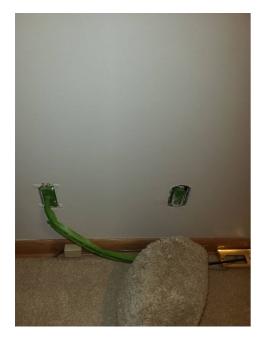
9.7.1 Lighting Fixtures, Switches & Receptacles

COVER PLATES MISSING

The bedroom being used as an office is missing cover plates. This will allow for shock or worse. Recommend installation of cover plates.

Contact a qualified electrical contractor.

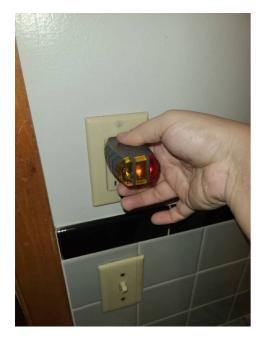
11.3.1 GFCI & AFCI **IMPROPER INSTALLATION**

GFCI does not work in half bathroom. This will allow for shock or worse. Recommend a reputable licensed electrical contractor.

Contact a qualified electrical contractor.
